(NASA-CR-134816-Vol-1) T-111 RANKINE SYSTEM CORROSION TEST LOOP, VOLUME 1 Final Report (General Electric Co.) 276 p HC \$9.25

T-111 RANKINE SYSTEM CORROSION TEST LOOP

Volume I

Nuclear System's Programs Missile and Space Division GENERAL ELECTRIC COMPANY

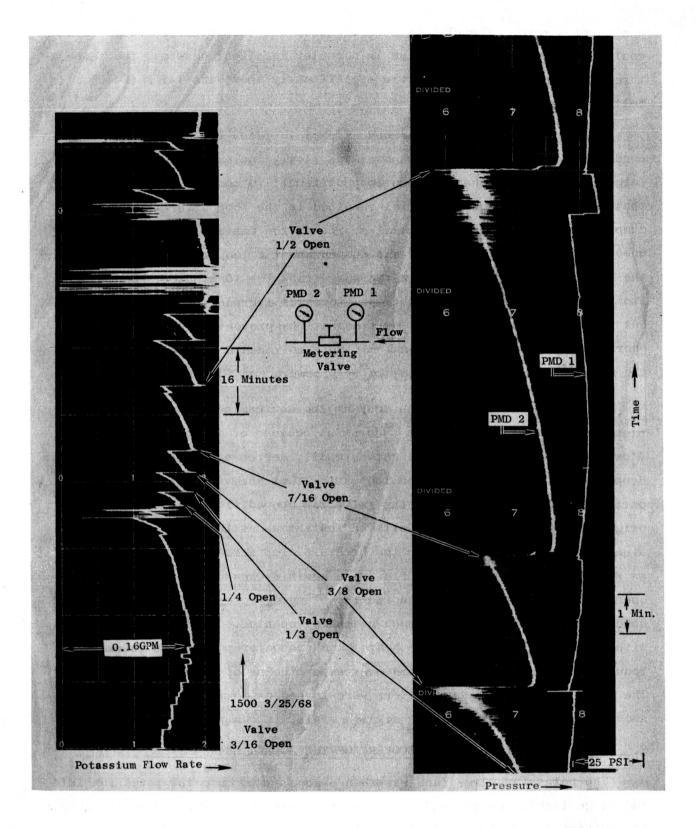
Figure 59. The Effect of Plugging the Metering Valve on Potassium Flow Rate and Pressure Drop Across the Metering Valve During Operation of the T-111 Rankine System Corrosion Test Loop.

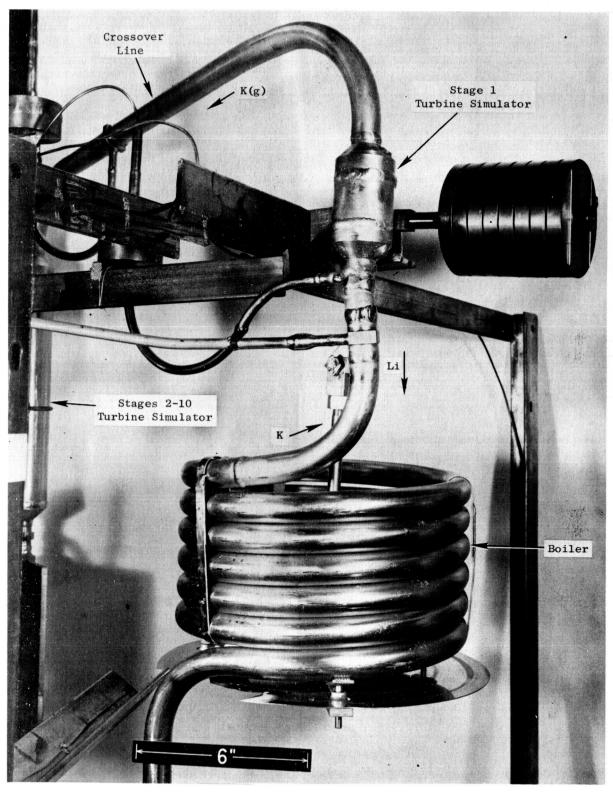
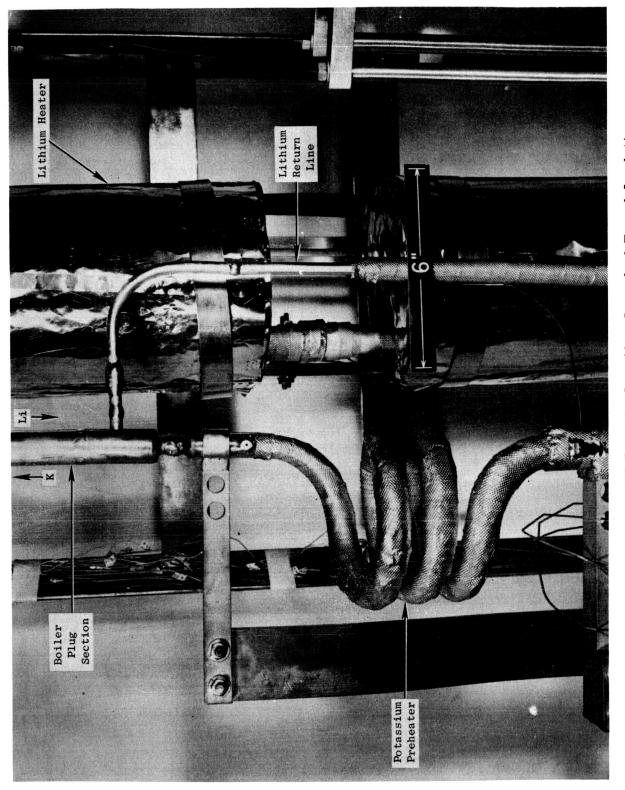
Following removal of the alkali metal from the loop and surge tanks, all electrical power and water cooling was turned off. After the loop and vacuum chamber had cooled to room temperature, the bell jar was removed. Visual inspection of the loop and all related components showed them to be in excellent condition. Except for isolated areas in close proximity to the stainless steel support structure, there was no discoloration of the Cb-1Zr dimpled-foil, thermal insulation. Photographs of the loop prior to any disassembly or removal of foil are shown in Figures 75, 76, 77. Figure 75 shows the boiler (insulation package still in place, lithium inlet line to boiler, both turbine simulators, crossover line, the top of the condenser section, and two of the pressure transducers. Figure 76 shows the bottom of the boiler insulation package, boiler plug section, condenser, potassium preheater, lithium heater, and lithium inlet and return lines. Figure 77 is a photograph looking down into the spool piece illustrating, in addition to the items described above, the shutter assembly, potassium surge tank, and both valve assemblies. Close examination of the metering valve revealed that the reason it became inoperative during the test is because the coupling connecting the spur gear shaft with the flexible cable had become disengaged. * Following this initial visual examination, thermocouples and the thermal insulation were removed from the boiler, turbine simulators, and crossover line, the loop components which were to undergo posttest evaluation. All the Cb-1Zr thermal insulating foil removed from the loop was ductile, and no visible evidence of contamination was noted. After removal of the thermal insulation, these components were reinspected visually. Again, they were found to be in excellent condition as shown in the photographs of the boiler and plug regions in Figures 78 and 79.

Figure 78. T-111 Corrosion Test Loop Boiler and Turbine Simulator Following Removal of the Thermal Insulation. (Orig. P70-4-1A)

Components of T-111 Corrosion Loop After Removal of Thermal Insulation From Areas to Undergo Posttest Evaluation. (Orig. P70-4-1C) Figure 79.

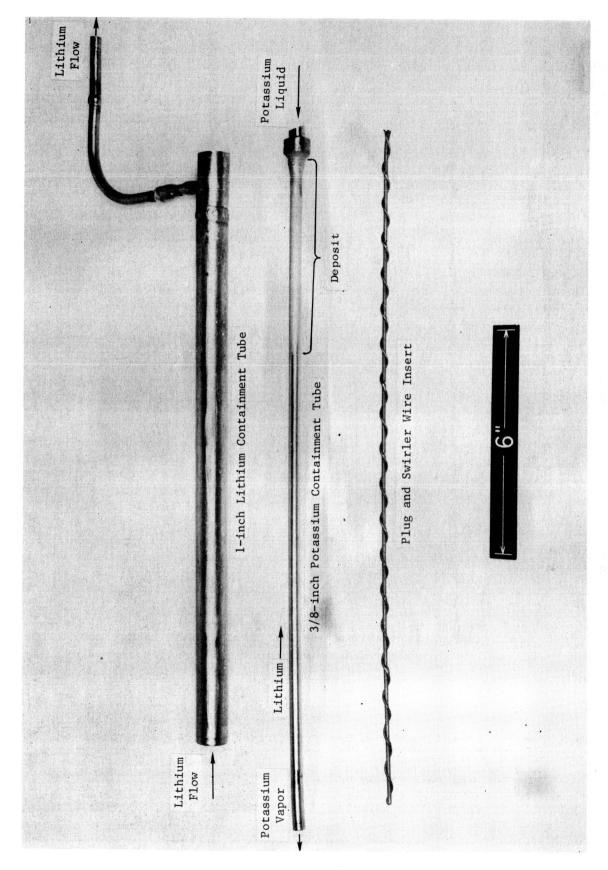
Components of Boiler Plug Section of T-111 Rankine System Corrosion Test Loop Following 10,000 Hours of Continuous Operation. (Orig. P70-5-1M) Figure 84.

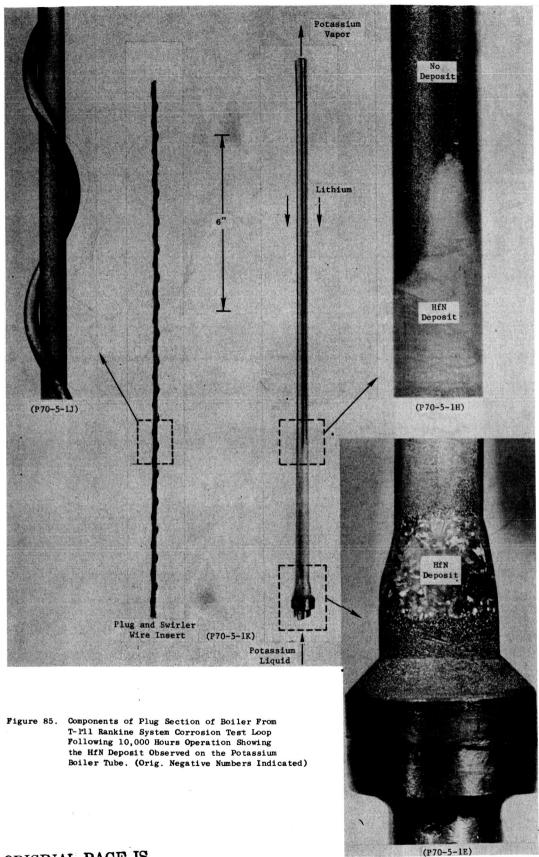
The plug section of the boiler was disassembled as shown in Figure 84 by filing the welds at the bottom fitting and at the bottom of the swirler wire. The most interesting observations were made on the 3/8-inch (0.95-cm) potassium containment tube which is shown in Figure 85. Of particular interest is the gold-colored deposit on the outer surface of the tube.

The gold-colored deposit, which has been identified as HfN by X-ray diffraction techniques, appeared heaviest in the region of the fitting shown in the inset of Figure 85. As may be noted in Figure 85, the deposition on the outer surface of the boiler tube and fitting was confined to the last five inches of the lithium flow path in the boiler (first five inches

of the potassium flow path). In this relatively short length, the lithium temperature dropped approximately 50°F. This temperature drop was approximately 40 percent of the entire lithium temperature drop in the boiler and corresponds to the high heat flux potassium nucleate boiling region of the plug section of the boiler. This sharp temperature drop in the lithium made the outer surface of the boiler tube, which was the lowest temperature surface in contact with the lithium in the entire lithium circuit, an ideal location for deposition of elements which are in solution in the flowing lithium. A very similar deposition of zirconium and oxygen was noted in the plug section of the boiler in the 5000-hour Cb-1Zr Rankine System Corrosion Test Loop. (22) The wavy appearance of the deposit - no deposit transition evident in Figure 85 - probably results from the potassium flow pattern induced by the swirler wire in the plug section. No deposit or discoloration was observed on the swirler wire-plug insert, as can be seen in Figure 85.

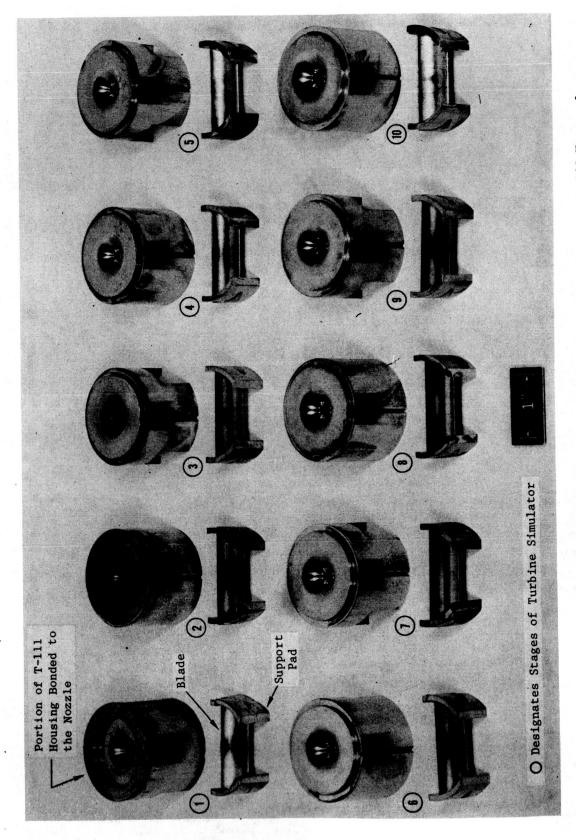
Turbine Simulator Nozzles, Blades, and Support Pads Following 10,000 Hours of Exposure to Potassium Vapor in the T-111 Rankine System Corrosion Test Loop. All Are Mo-TZC Except Stages 6 and 9 Which Are Cb-132M. (Orig. P70-5-6M) Figure 88.

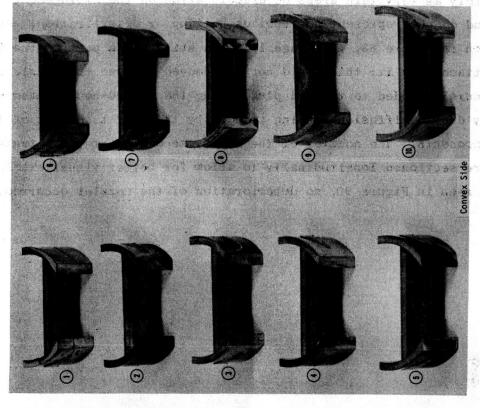
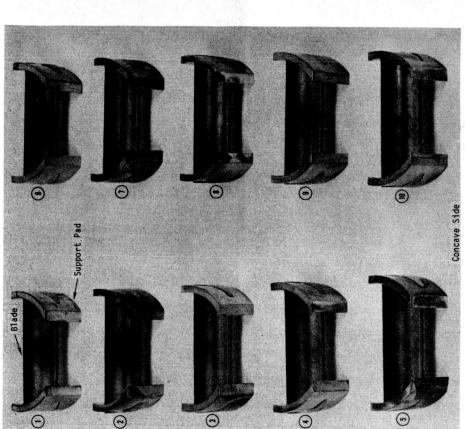
The nozzles and blades were removed from the turbine simulators by making a longitudinal cut in each of the housings, as described previously. (23) The appearance of all blades and nozzles was very good, and no signs of gross corrosion or erosion were observed. Potassium vapor flow patterns were observed on the blades, as seen in Figures 88 and 89. The flow patterns

Concave and Convex Side of Turbine Simulator Blades Following 10,000 Hours Exposure to Potassium Vapor in the T-111 Rankine System Corrosion Test Loop. All Are Mo-TZC Except Stages 6 and 9 Which Are Cb-132M. (Orig. P70-5-6P and P70-5-6N) Figure 89.

appear merely as very thin areas of discoloration on the impingement surface and do not represent any serious buildup or deterioration. As can be seen in Figure 88, the stage I nozzle still has a part of the T-111 housing attached to it; this could not be removed because the nozzle had become securely bonded to the end plug during the 10,000-hour exposure, apparently due to diffusion bonding induced by the very tight fit of the mating components. The nozzles of the first, second, sixth, and tenth stages were sectioned longitudinally to allow for better visual examination. As can be seen in Figure 90, no deterioration of the nozzles occurred.

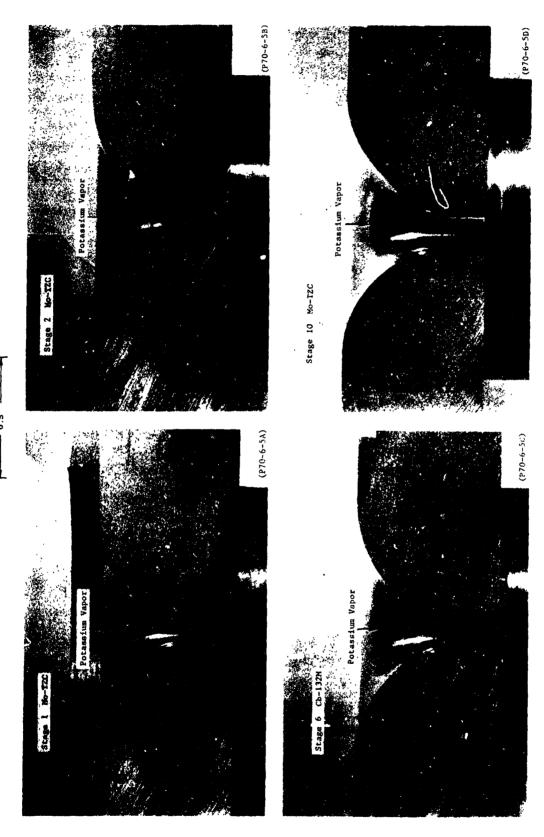
Figure 90. Longitudinal Cross Section of Turbine Simulator Nozzles Following 10,000 Hours of Exposure to Fotassium Vapor in the T-11 Rankine System Corrosion Test Loop.

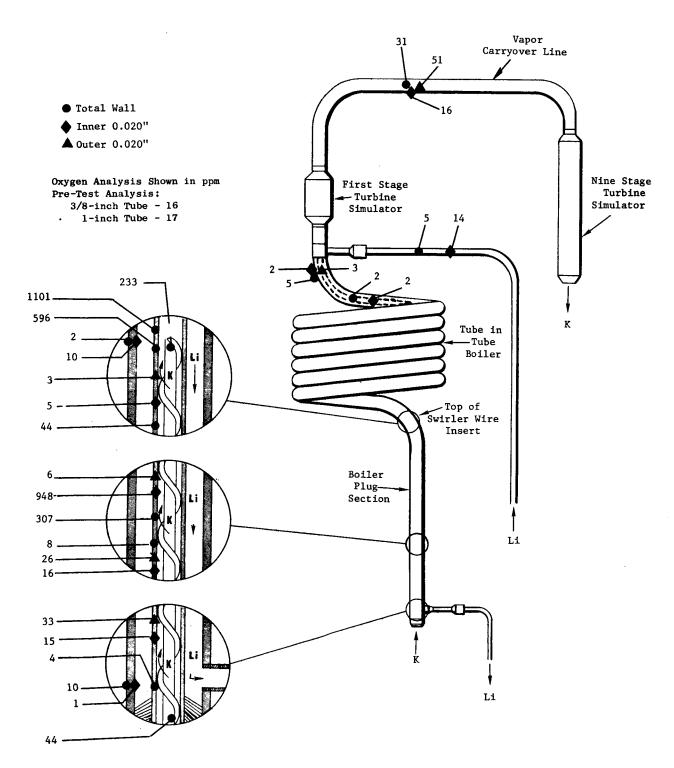
The oxygen concentrations in the 1-inch (2.54-cm)-diameter T-111 tubing, the ID of which was exposed to lithium, are all < 10 ppm. clearly indicates dissolution of oxygen from the T-111 by the lithium. The oxygen concentrations in the 3/8-inch (0.95-cm)-diameter T-111 tubing exposed to lithium on the OD and potassium on the ID are less consistent, with some large highly localized oxygen concentrations indicated. analytical results of the inner and outer wall segment specimens of the potassium containment tube coupled with the oxygen dissolution observed in the 1-inch (2.54-cm)-diameter tube indicates that the most likely oxygen source is the high-temperature regions of the potassium circuit. oxygen concentration of the potassium boiler tube as a function of distance from the potassium inlet to the boiler is summarized in Table XXVII. Two high-oxygen peaks were observed; the first was found 5 to 6 inches (12.7 -15.2 cm) from the potassium inlet (lithium exit), and the second was found 16 to 18 inches (40.6 - 45.7 cm) from the potassium inlet. It is currently believed that the first oxygen peak is associated with the region where the inner wall of the potassium containment tube (3/8 inch, 0.95 cm) becomes essentially dry. From this region to the end of the plug section most of

Figure 92. Results of Oxygen Analysis of Loop Components.

the remaining potassium liquid is assumed to be carried along on the swirler wire and centerbody. It is hypothesized that as liquid potassium is converted to vapor in this area, the oxygen concentration of the remaining liquid becomes increasingly higher until it finally is concentrated at the wall and contaminates the T-lll either by absorption and interstitial diffusion and/or reaction (corrosion). Metallographic examination of specimens from this area, which will be discussed later in this section, shows some localized corrosion in this area.

As indicated, the second oxygen peak occurs near the end of the swirler wire-plug insert. A recently completed experimental study at GE-NSP on air-water flow has shown the behavior of liquid in tubes containing swirl generators similar to that employed in the T-111 Corrosion The results of the air-water flow study as applied to the T-111 Loop. Corrosion Loop would indicated that the ID of the potassium containment tube will become void of liquid potassium downstream from the end of the insert; however, liquid potassium will still flow on the plug insert since the pressure is relatively low in the center. At the end of the insert, this liquid potassium is thrown to the ID of the potassium con- . tainment tube where it immediately is converted to vapor. The transfer of liquid from the plug insert to the containment tube wall is illustrated for the air-water flow tests in Figure 93. (24) Since the air-water tests are performed at ambient temperatures, the conversion to vapor on contact with the tube wall does not occur as it does for the case when the tube walls are hot, as in a boiler. Oxygen contamination of the T-111 wall in this area can therefore occur by the same process as described in the preceding paragraph. The oxygen concentrations of the centerbody and swirl wire at the top end of the plug were also high, supporting this postulate.

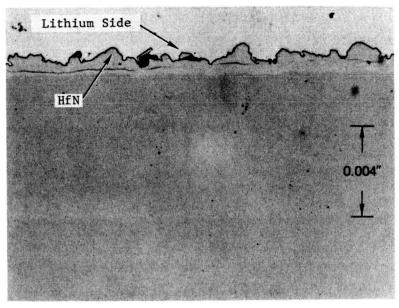
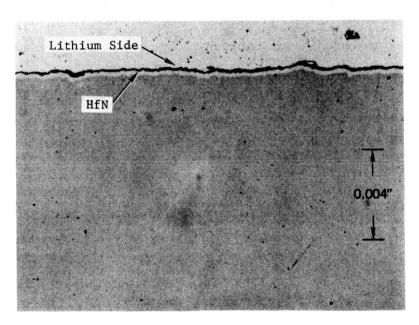
were taken about six inches above the fitting and from two areas near the top of the swirler wire insert. The HfN coating was best examined in the as-polished condition, as shown in Figure 96, since the etchant used for T-111 attacked the HfN rather rapidly. The major difference between the microstructure shown in Figure 96a, which is taken from the weld area, and that shown in Figure 96b, which represents the tube OD surface about 1/2 inch above the weld, is the thickness of the HfN coating. The weld region operated at the lowest temperature in the plug region, and in this area the coating on the weld is much thicker than the coating on the tube. Examination of the ID (potassium) surface of this specimen indicated anomalous microstructural features at the fitting weld metal and tube weld metal interfaces. The microstructure shown in Figure 97 is from the fitting weld metal interface and is typical of these anomalous microstructural features. In the as-polished condition they appear as a light and dark island within the normally gray-colored T-111 matrix; however, after etching, the affected area is seen to be much larger than indicated in the as-polished condition and generally contains a relatively heavily etched (black) core. Note also the evidence of grain-boundary attack on the periphery which does not show up in the as-polished condition. this grain-boundary structure results from potassium attack or reaction of material in the grain boundaries with the etchant is difficult to ascertain. Microprobe analysis of this area for Ta, Hf, W, K, Fe, and Cr showed the area to be rich in Fe and Cr as illustrated by the X-ray scans in Figure 98; no other elements were detected. Although the source of the Fe and Cr cannot be readily explained, their presence in the potassium circuit is undoubtedly related to the previous findings of Fe, Cr, and Ni in the residue from the distillation of the potassium drained from the loop as discussed in Section XI. Presumably the original source is inadvertent contamination by stainless steel; however, the exact source and the reason for the particularly high concentration in this one weld area are currently unknown. It should be pointed out that all other areas where microprobe evaluation was performed were also checked for Fe and Cr; however, no indications were found. Microhardness traverses in the vicinity of these areas showed them to have a hardness of 200-225 units higher than the average matrix hardness of about 225 DPH (100-gram load).

a. On weld metal at tube-fitting interface

b. On tube approximately 1/2-inch above fitting

Figure 96. Hafnium Nitride Deposit Near Bottom of 3/8-Inch (0.95-cm)-OD T-111 Tube in Plug Section of Boiler.

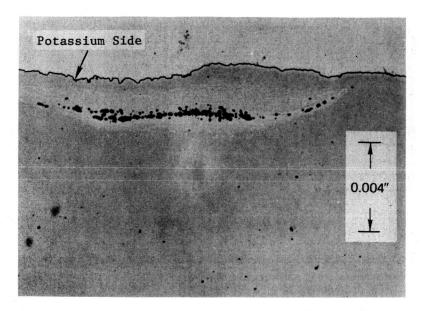
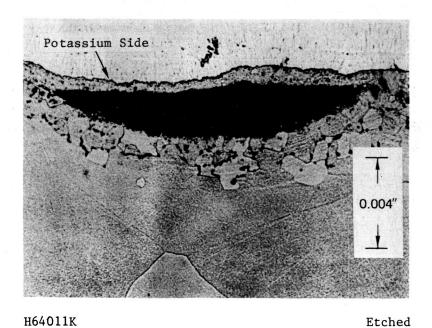
Figure 97. Base Metal - Weld Interface at Bottom of the 3/8-Inch (0.95-cm)-OD T-111 Potassium Containment Tube in the Plug Section of the Boiler Before and After Etching.

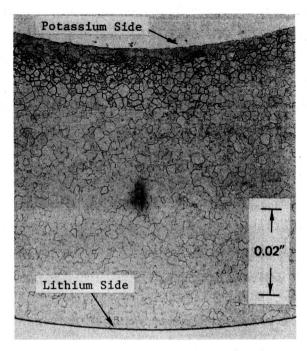
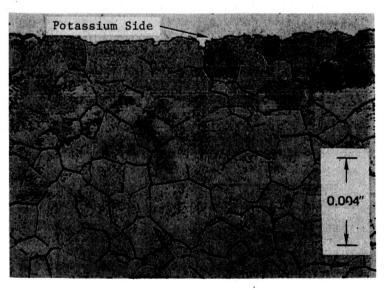
Potassium Side A transverse specimen from the 3/8-inch (0.95-cm) tube was cut from an area near the edge of the HfN-coated region which occurred six inches (15 cm) above the lithium exit. This region of the tube is believed to correspond to the area where the ID of the tube begins to be exposed to vapor approaching 100-percent quality, as supported by the fact that the oxygen concentration at the ID below the interface was 16 ppm while just above the interface it was 948 ppm (Table XXV). Some evidence of localized corrosion was evident in this area as shown in Figure 99. The corrosion area was localized, i.e., it did not extend around the total ID surface but was essentially confined to the area shown in Figure 99. This localized effect is believed to be associated with the swirling of the flow path and probably corresponds to transformation of high-oxygen liquid to pure potassium vapor in this local area. Microhardness measurements showed no difference or gradients among various locations in the specimen.

The transverse specimen was reground, repolished, and rough polished dry to attempt to determine if any free potassium was present in the corroded area. Water was applied to the surface of the freshly polished surface while observing the specimen under the microscope. No evidence of gas evolution was detected which indicates that there was no free potassium metal present in the corroded area. Additional polishing and examination in the unetched condition revealed a nonmetallic, semicontinuous phase in the grain boundaries of the corroded region. The phase may be potassium tantalate (K₃TaO₄) since this phase has been detected in solubility experiments of oxygen-doped tantalum in potassium. (27) Also, microprobe examination of the swirler insert, discussed later in this section, revealed the presence of potassium in similar-appearing grain-boundary precipitates.

Figure 99. T-111 Potassium Containment Tube to the Plug Section
Approximately 6 Inches (15 cm) Above Lithium Exit From
Boiler.

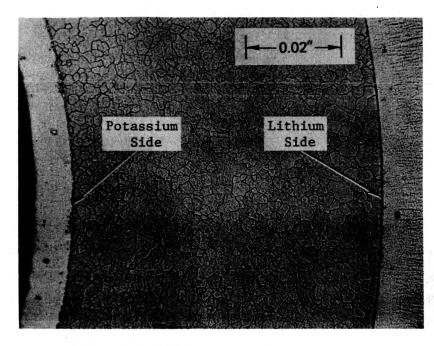
Two specimens were obtained from the 3/8-inch (0.95-cm) tube near the top of the plug section. The first section to be examined was cut essentially even with the top of the swirler wire insert and consisted of a clean, equiaxed microstructure as shown in Figure 100. Since the chemical analysis in this region of the tube had indicated both high oxygen concentration (1100 ppm) and a very steep oxygen gradient, it was decided that an additional

Figure 100. T-111 Potassium Containment Tube in the Plug Section of the Boiler Adjacent to the Top of the Swirler Wire Insert.

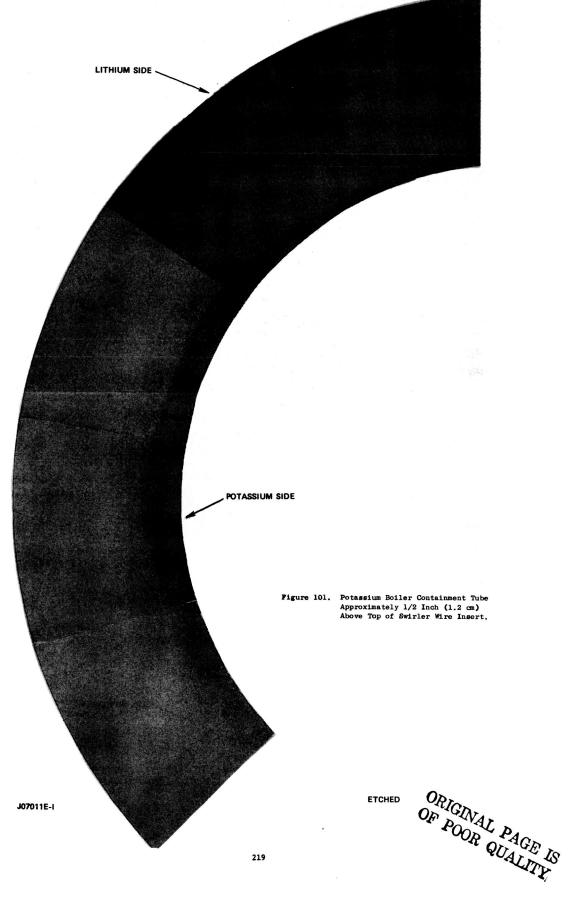
specimen should be taken from an area closer to the higher oxygen specimen (1/2 inch, 1.3 cm) above the end of the swirler insert. The microstructure of the second specimen, shown in Figure 101 revealed an uneven zone near the ID. This region is assumed to be the high-oxygen region. The postulated reason for the high oxygen concentration in these regions was discussed earlier in this section. It can be seen in Figure 101 that the reaction zone at the tube ID is not uniform in thickness. This nonuniformity could be a result of the swirling action of the potassium being ejected from the end of the swirler wire insert. The reaction zone consists of three different regions as shown in Figure 102. The microstructure of the region closest to the ID, Figure 102a, consists primarily of a very fine, evenly divided precipitate in the matrix and a slightly coarser grain-boundary precipitate. Near the midwall, the microstructure, illustrated in Figure 102c, is dominated by a relatively large grain-boundary precipitate and somewhat fewer in number but equally large matrix precipitate. The transition region, shown in Figure 126, consists primarily of a fine matrix precipitate and an area immediately adjacent to it of large grain-boundary precipitates but clean matrix. Microprobe analyses were performed on this specimen to determine the identity of the precipitate particles. Although the identity of the fine particles could not be determined, because the size is below the resolution limit of the microprobe, the larger particles are believed to be hafnium oxide because (1) the hafnium content in the region of the larger particles was approximately four times that of the matrix and (2) all of the larger particles fluoresced in the electron beam, a characteristic unique to oxides.

T-111 Potassium Containment Tube 1/2 Inch (1.2 cm) Above the Top of the Swirler Wire Insert. Same Area as Figure 101. Figure 102.

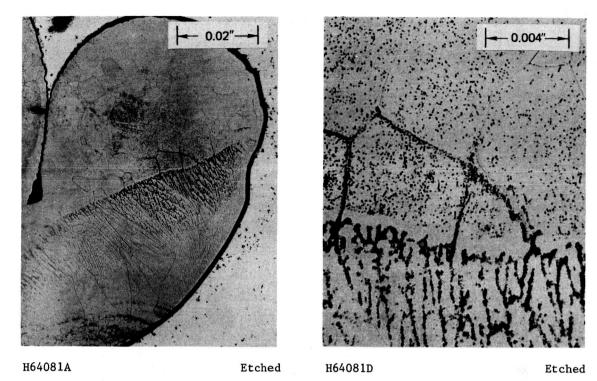
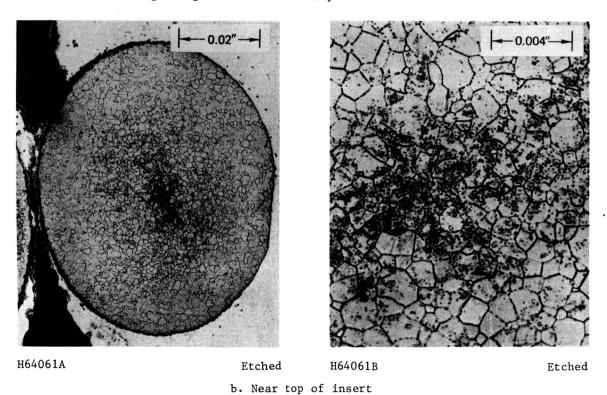
Specimens of the swirler wire insert from the lower portion of the plug section, six inches (15 cm) from the lithium exit, and from the top region of the plug were also examined. The microstructures of these specimens are shown in Figure 103. Microprobe analyses were performed on these specimens in an attempt to characterize the dark regions in these specimens. Results from the top sample showed the hafnium content of some of the dark particles to be three times that of the matrix; however, analyses of the bottom specimen did not reveal anything of significance. The metallographic specimen from six inches above the lithium exit represents a specimen adjacent to the 3/8-inch (0.95-cm) tube section shown in Figure 99. As seen in Figure 104, a similar effect was observed in the swirl wire as was seen in the tube section, i.e., a very localized area of intergranular corrosion. To determine

a. Near bottom - potassium inlet showing tack weld joining wire and centerbody

Figure 103. T-111 Swirler Wire From Plug Section of Boiler.

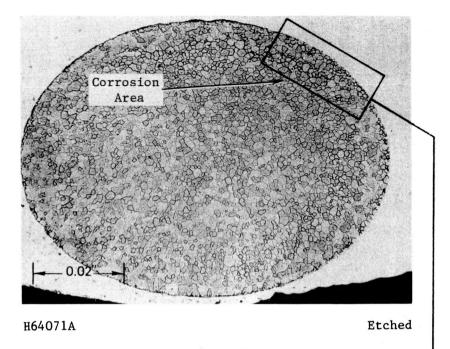
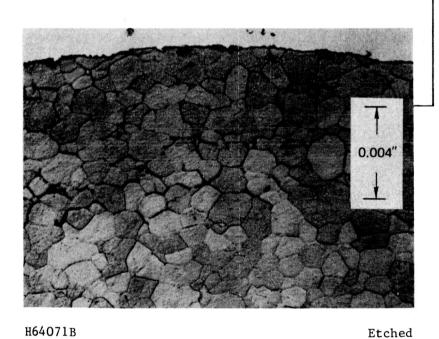
a. Overall

b. Corrosion area

Figure 104. T-111 Swirler Wire From Plug Section of the Boiler Approximately 6 Inches (15 cm) From the Lithium Exit.

if this effect was assocated with the swirling action as proposed earlier. the specimen was reground to determine if the corrosion area appeared in a different location. On re-etching it was found that, indeed, the area had rotated significantly from the original location supporting the swirling effect. Microhardness traverses in several areas of these specimens showed no significant deviation from the nominal matrix hardness. Microprobe analysis was performed on this specimen in order to determine the composition of the grain-boundary phase. The results show that the grain-boundary phase contains small concentrations of potassium and carbon; no other elements were detected. Since the particles did not fluoresce in the electron beam, it can be concluded that they are not pure oxides; however, it does not preclude the possibility of oxygen being present in quantities below the detection limit of the microprobe or possibly ${\rm K_3{TaO}}_4$ as mentioned in connection with Figure 99. The precipitate particles were too small and the signals too weak in order to further identify their exact composition. Based on these results and the work performed on the adjacent 3/8-inch (0.95-cm) tube specimen discussed earlier in this section, it appears that the precipitate is a complex potassium compound.

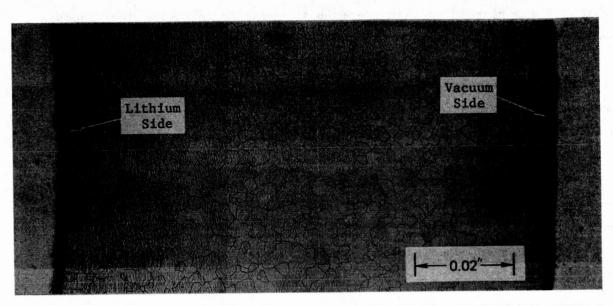
H64101A,B

Specimens were also examined from the 1-inch (2.54-cm) tube at the top and bottom of the plug section. No differences could be seen from the pretest material except perhaps a very slight amount of grain growth as shown in Figure 105 (compare with Figure 95).

Figure 105. Lithium Containment Tube (1-Inch, 2.5-cm OD) From Top of Plug Section.

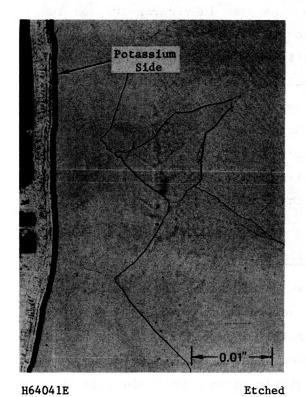
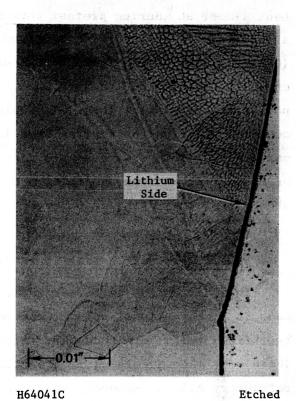
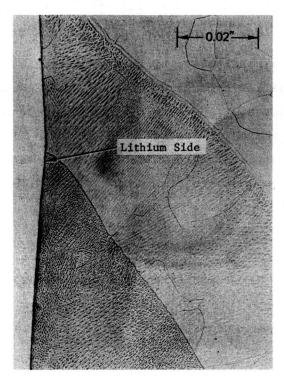
H64121A Etched

Two areas were examined from the coiled portion of the tube-in-tube boiler: (a) the repair weld region and (b) sections from the top of the boiler which were representative of the hottest (2240°F, 1225°C) part of the boiler. The repair welds on both the 3/8- (0.95-) and 1-inch (2.54-cm) tubing appeared to be in excellent condition as shown in Figure 106. The areas shown represent the weld metal - base metal interface, which past experience has shown to be the most critical from the standpoint of alkali metal compatibility. No evidence of any corrosion could be detected.

a. 3/8-inch OD potassium containment tube

b. 1-inch OD lithium
 containment tube

Figure 106. Repair Welds in Top Coil of the 3/8-Inch (0.95-cm) and 1-Inch (2.5-cm) T-111 Tubing From the Boiler.

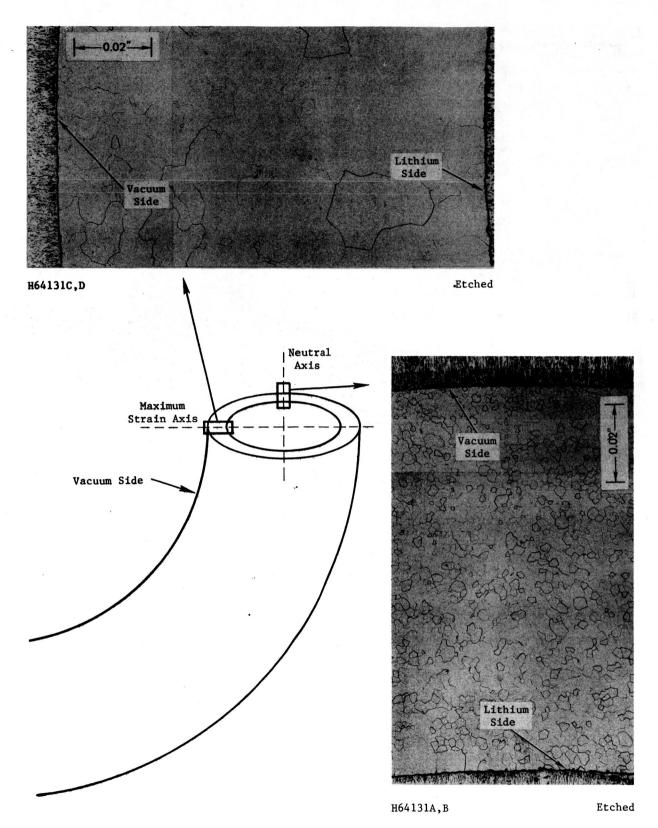
Figure 107. Lithium Containment Tube From Top of Boiler Following 10,000 Hours of Continuous Operation at Approximately 2240°F (1227°C) Illustrating Effect of Strain From Pretest Forming Operation on Grain Growth.

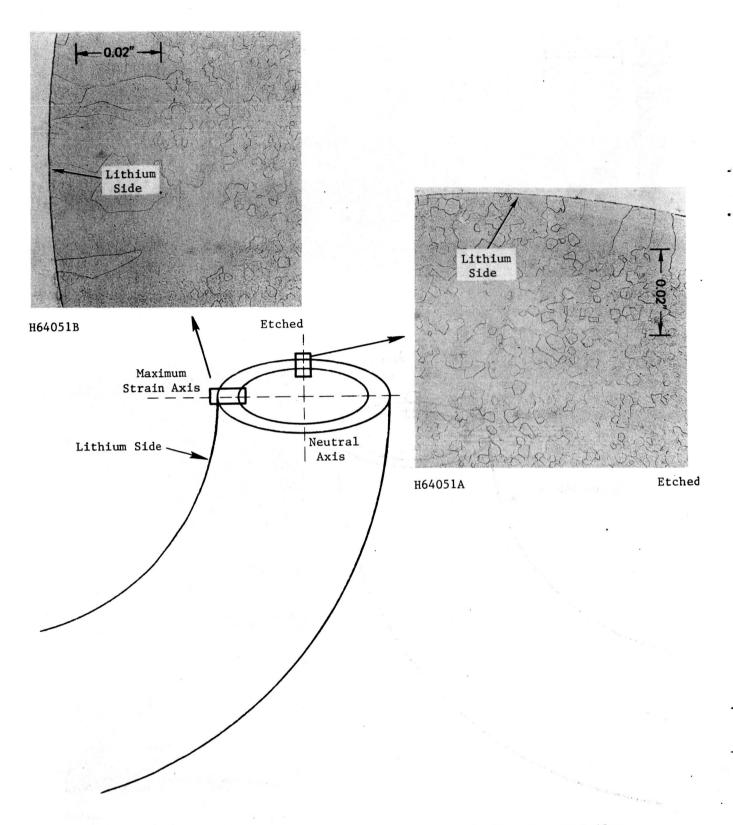
bent almost 90° during pretest forming. As seen in Figures 107 and 108, strain-induced grain growth occurred completely across the 0.1-inch (0.25-cm) wall of the 1-inch (2.54-cm) lithium containment tube and over one-half of the 0.060-inch (0.15-cm) wall of the 3/8-inch (0.95-cm) potassium containment tube. As would be expected, maximum grain growth occurred 90° from the neutral axis in both cases. In areas between the maximum and minimum stress axes, the microstructure (not shown) consisted of mixed fine and coarse grains. Similar, but much more spectacular abnormal grain growth was observed in the Cb-1Zr boiler from the earlier loop test. (28)

Figure 108. 3/8-Inch (0.95-cm) Potassium Containment Tube From Top of Boiler

Illustrating Effect of Strain From Pretest Forming on Grain Growth

During the 10,000-Hour Test. Adjacent to Sample in Figure 107.

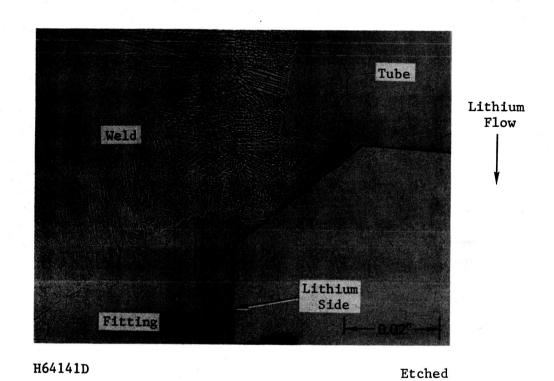
Since there was a possibility of unknown variables which could have influenced the weld quality because of the new techniques utilized in the field installation, three of the four field welds were examined metallographically. Two of these were socket welds, in the lithium circuit. The weld exposed to the hottest lithium (2250°F, 1230°C) at the inlet to the boiler (heater exit) is shown in Figure 109. No detrimental effects were detected due to the 10,000 hours' exposure to flowing lithium. The second socket weld was located on the lithium exit line from the boiler (2090°F, 1145°C). Although no indications of typical alkali metal attack were observed in this weldment, a very fine, somewhat banded, general precipitate was present as shown in Figure 110. This same type of structure was also seen to a somewhat lesser degree at the bottom of the plug section discussed

Figure 109. Repair Socket Weld in 3/8-Inch (0.95-cm) Lithium Inlet to the Boiler.

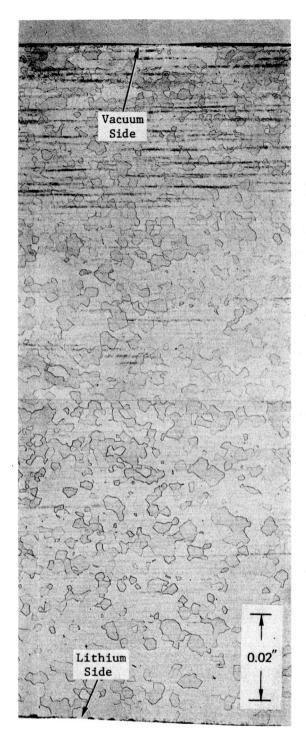
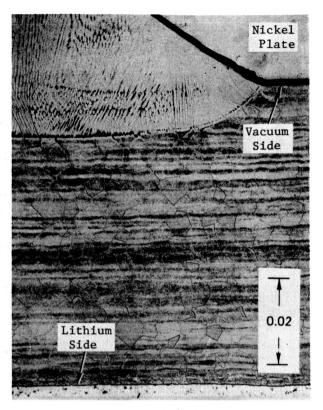
H64151H

Figure 110. Repair Socket Weld in 3/8-Inch (0.95-cm)-OD Lithium Exit Line From Boiler.

earlier in this report and also in the T-111 portion of the High-Temperature Alkali Metal Valve Loop. (29) Note in Figure 110 that although the second phase extends completely through the 0.062-inch (0.16-cm) wall of the 3/8-inch (0.95-cm)-OD tube, only about 1/3 of the outer portion of the fitting wall shows the precipitate. As shown in the higher magnification photomicrographs of Figure 111, the precipitate appears as small, individual, globular-type precipitates in both the matrix and grain boundaries. Since this precipitate does not appear to adversely affect the reliability of the alloy in an alkali metal system in any obvious manner, no attempts were made to identify it. The random locations of this fine precipitate in tested T-111 components suggests that its presence is related to compositional inhomogeneities and thermal effects rather than liquid metal interactions.

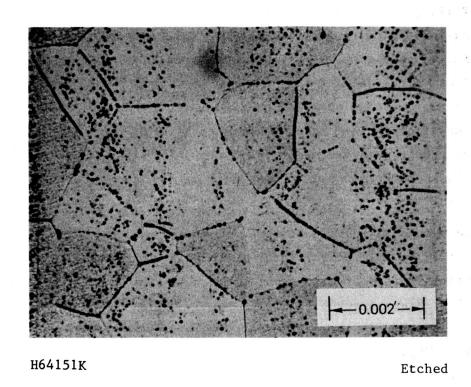
Figure 111. Repair Socket Weld in Lithium Exit Line From Boiler. Same Area as Figure 110.

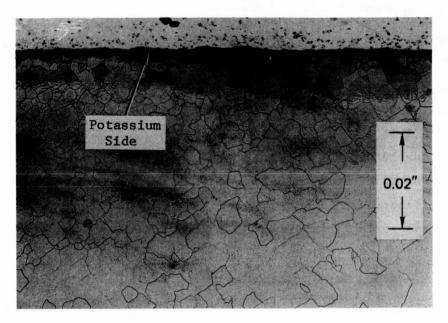
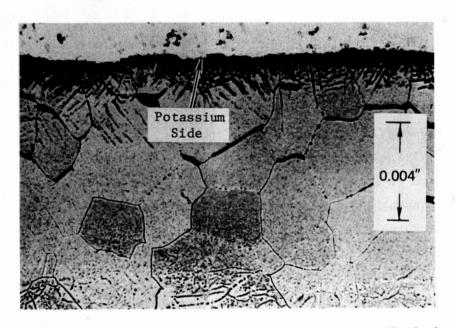
H64161D Etched

Although no attack was observed in the installation welds discussed above, intra- as well as intergranular alkali metal attack was detected in the heat-affected zone of the field repair weld joining the boiler exit to the first-stage turbine simulator housing inlet. The attacked area was relatively small, and maximum penetration was about 0.005 inch (0.013 cm) as shown in Figure 112. Also indicated in Figure 112 is a very fine reaction layer in addition to the gross grain-boundary attack. This same type of reaction layer can also be seen in the corrosion area of the 3/8-inch (0.95-cm) tube from the plug section previously shown in Figure 99.

The metallographic appearance of the attack suggests that it resulted from localized oxygen contamination and this might be possible despite the fact that (a) extreme care was taken during all phases of the repair and installation sequence to avoid contamination and (b) similar procedures were utilized for the other installation welds, and they showed no evidence of attack. At any rate there is no known mechanism which would suggest that the attack continued with test duration, and only an insignificant portion of the wall thickness was affected. The attack observed in this specimen again points out the usefulness of extensive metallographic examination in detecting areas of localized attack.

Figure 112. Heat-Affected Zone of Field Weld Joining Top of Bo Bottom of First-Stage Turbine Simulator.

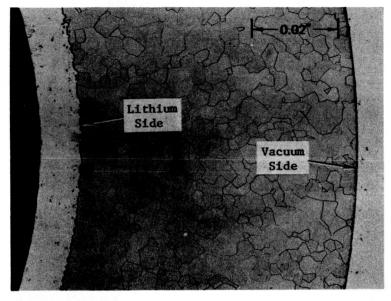
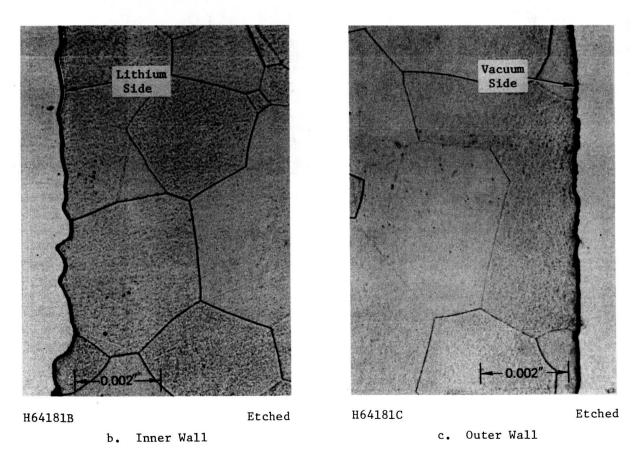
A section from the 3/8-inch (0.95-cm) line between the lithium heater and boiler inlet was examined since it represents tubing exposed to the highest loop temperature (2250°F, 1230°C). This material exhibited the cleanest microstructure of any of the tubing examined as shown in Figure 113. This is consistent with the very low posttest oxygen concentration (5 ppm) of this tubing. It may also be noted in Figure 113 that the grain size is approximately three times that of the pretest material previously illustrated in Figure 95a. Also, note that this is still considerably less grain growth than was noted at the top of the boiler (Figures 107 and 108) where strain during boiler fabrication resulted in nonuniform grain growth during the test.

H64181A Etched a. Total Wall

Figure 113. Lithium Line Connecting Heater Exit to the Boiler Inlet.

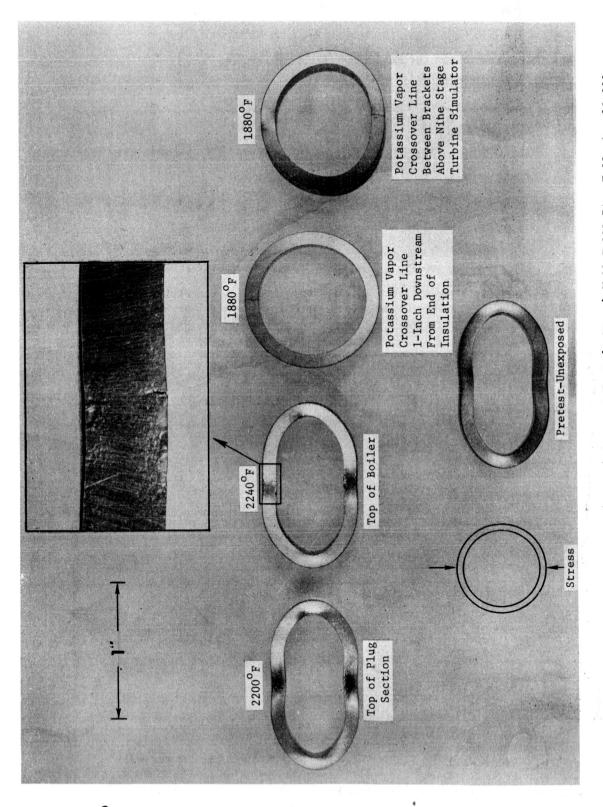
Specimens of 1-Inch (2.5-cm)-OD x 0.1-Inch (0.25-cm)-Wall T-111 Pipe Following 10,000 Hours' Exposure in the T-111 Rankine System Corrosion Test Loop. Ring Specimens (Orig. P70-6-4D) Deformed at Room Temperature. Figure 114.

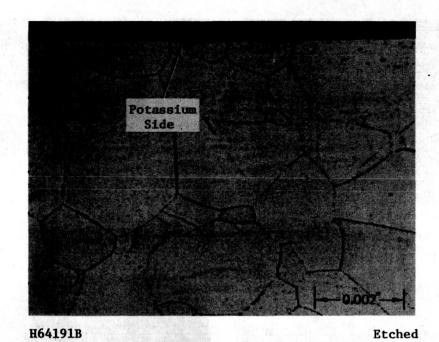
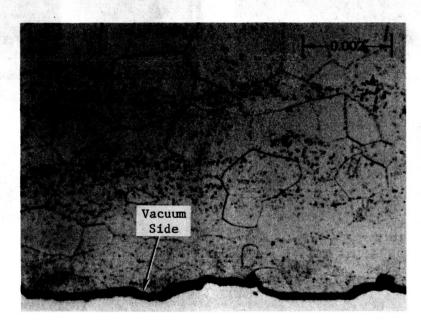
H64191I

The vapor crossover line was examined because flattening tests showed this material to be the most brittle in the loop. As shown in Figure 114, compressing of ring segments from the crossover line caused fracture with little or no deformation while similar tests on specimens of pretest material and boiler pipe exhibited excellent ductility. Although some very small cracks were observed in the boiler specimens, they occurred only after considerable deformation and did not propagate rapidly. On the other hand, the crossover line cracked with little or no deformation, and the crack propagated instantaneously across the wall. Except in rare occasions, most cracks initiated on the ID at the location of the maximum tensile strain. Optical microscopy of a specimen from the vapor crossover line showed the presence of a fine, grain-boundary precipitate throughout the cross section as illustrated in Figure 115. Because of the low ductility of this material, Scanning Electron Microscopy (SEM) was performed on specimens from the fractured ring specimens. For comparison, the SEM study also included ductile specimens from the boiler and the pretest material. The results showed, in agreement with the optical microscopy, that the grain boundaries of the vapor crossover tube contain a fine precipitate, and the samples break essentially 100 percent intergranularly as shown in Figure 116c. On the other hand, the boiler material and the pretest material broke in a much more ductile manner as shown in Figures 116a and 116b, and, where visible, the grain boundaries are void of precipitate particles. Qualitative

a. Inner Wall

b. Outer Wall

Figure 115. 1-Inch (2.5-cm)-OD Potassium Vapor Crossover Line Following 10,000 Hours of Continuous Operation at Approximately 1880 F (1027°C).

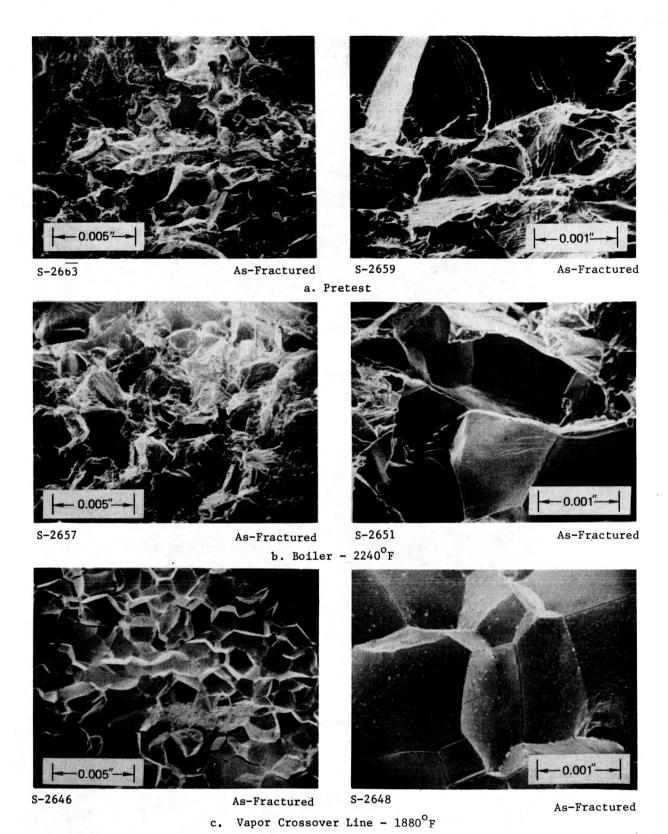
Figure 116. Scanning Electron Micrographs of Various Components of T-111.

Rankine System Corrosion Test Loop. All Are Fractures From Compression Tests on Rings From 1-Inch (2.5-cm)-OD Tubing.

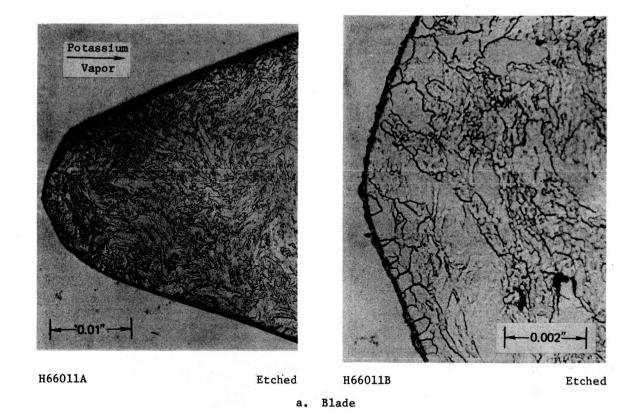
H66021B Etched

Sections from the Mo-TZC first, second, and tenth stages and the Cb-132M sixth-stage nozzle and blades were examined in the vapor impingement area. Typical pretest photomicrographs of each material are shown in Figure 117. No change in general microstructure was observed in any of the specimens examined as shown in Figures 118-121. The only anomalous feature is the 0.0003-inch (0.0007-cm) coating on the leading edge of the second-stage blade and nozzle as seen in Figure 119.

Figure 118. Mo-TZC Alloy First-Stage Nozzle and Blade Turbine Simulator Following 10,000 Hours of Continuous Exposure to Flowing Potassium Vapor in the Corrosion Test Loop.

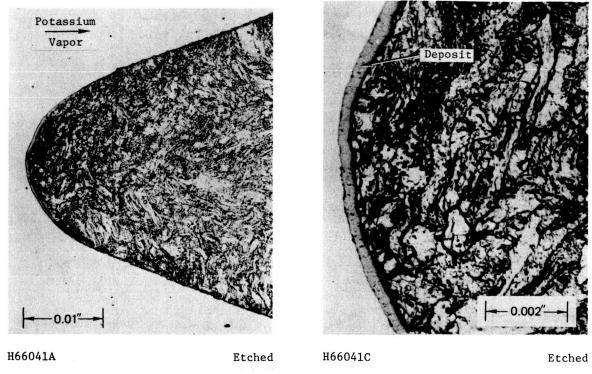
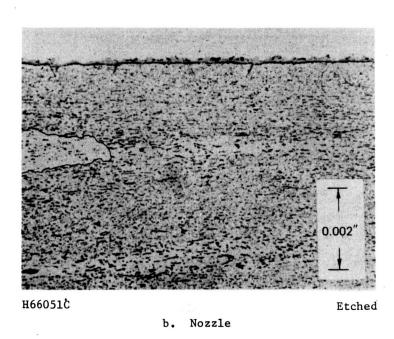
Microprobe examination was performed on the turbine simulator secondstage blade (Mo-TZC) in order to identify the deposit shown in Figure 119.
The microprobe results showed that the coating actually consists of two
separate layers. The outer layer was found to be essentially pure hafnium.
The second layer, located between the outer layer and the Mo-TZC substrate,
and much thinner than the outer layer, contained hafnium, but in much lower
quantities than the outer layer. Also, the inner layer contained Ti and
Zr in about the same quantities as the Mo-TZC substrate. These results
indicate that the hafnium was deposited from the potassium vapor onto
the surface of the blade and then diffused into the blade. Similar transfer
of hafnium from the hot to the cold portions of the lithium circuit was noted
earlier in this report in connection with the hafnium nitride coating on the
inner tube of the plug section of the boiler.

a. Blade

Figure 119. Mo-TZC Alloy Second-Stage Nozzle and Blade Turbine Simulator Following 10,000 Hours of Continuous Exposure to Flowing Potassium Vapor in the T-111 Corrosion Test Loop.

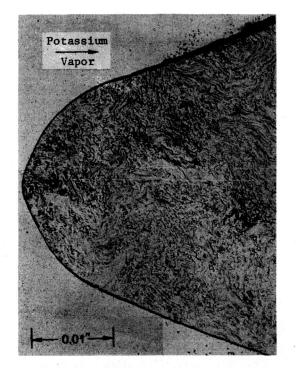
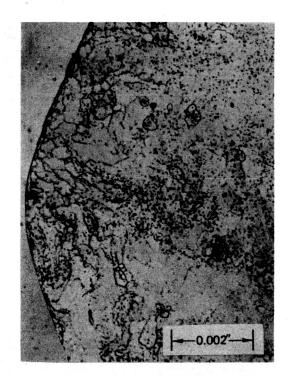
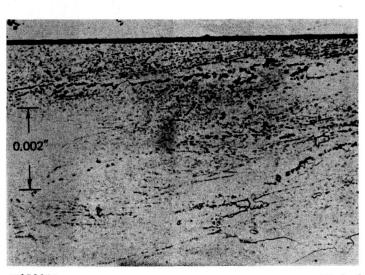
H65011B

a. Blade

b. Nozzle

Figure 120. Cb-132M Alloy Sixth-Stage Nozzle and Blade Turbine Simulator Following 10,000 Hours of Continuous Exposure to Potassium Vapor in the T-111 Corrosion Test Loop.

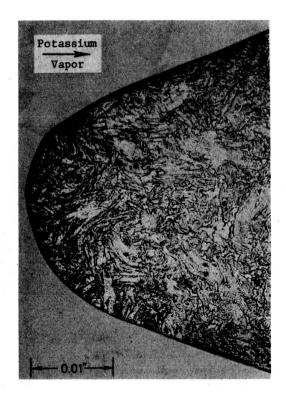
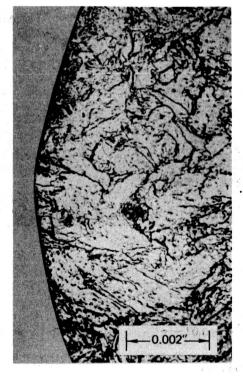
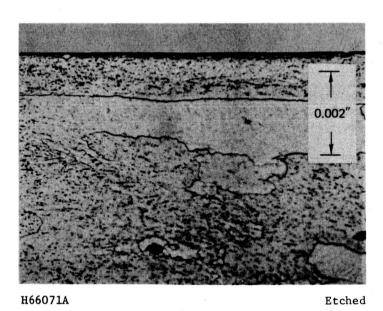
H66061A

a. Blade

. b. Nozzle

Figure 121. Mo-TZC Alloy Tenth-Stage Nozzle and Blade Turbine Simulator Following 10,000 Hours of Continuous Exposure to Potassium Vapor in the T-111 Corrosion Test Loop.

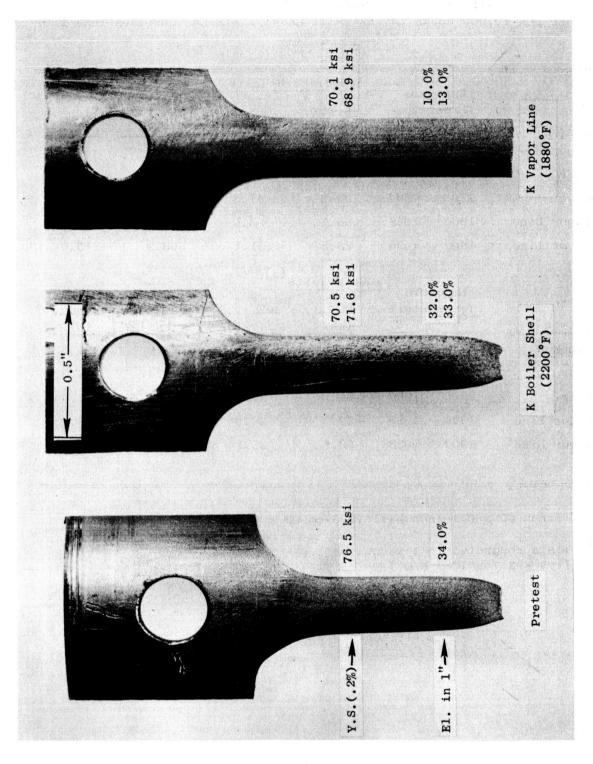
selected because they represent the longest straight sections from the loop which were exposed to the lowest (1900°F, 1040°C) and highest (2200°F, 1205°C) operating temperatures. Also, preliminary screening tests by crushing ring sectors at room temperature from several locations in the loop, discussed earlier in this section (Figure 114), showed the crossover line to have very low ductility; whereas, the boiler material exhibited only slightly reduced ductility compared to the pretest pipe. As shown in Figure 122, the specimens were similar to conventional, flat, tensile specimens; however, they were longitudinal sections from the 1-inch (2.54-cm) pipe. Although the results from this type of specimen may not be useful for engineering design purposes, they are valid for comparison of relative properties or property changes such as was the intention of this study. The results of the room temperature and 2000°F (1095°C) tensile tests are summarized in Table XXXII. At both room temperature and 2000°F (1095°C) the strength of all the specimens is essentially the same except that the unexposed pretest material may be slightly stronger at both temperatures. The only significant deviation in properties is the relatively low room temperature ductility of the vapor crossover line compared to either the boiler or unexposed pretest material. The appearance of the tensile test specimens following fracture is shown in Figure 123. This reduced room temperature ductility confirms the validity of preliminary results on the ring sector tests from this loop and the High-Temperature Alkali Metal Valve Loop. (30) The results of evaluating specimens from both loops indicate a possible aging reaction for T-111 at 1900°F (1038°C).

Fractured Tensile Test Specimens Cut From 1-Inch (2.5-cm) T-111 Pipe of the 10,000-Hour T-111 Corrosion Test Loop. Tensile Tests Performed at 80 F (27°C). (Orig. P70-10-16C) Figure 123.
